A brief overview of climatization strategies of historic houses in the Netherlands: From “one size fits all” to “a process of deliberation”

Bart Ankersmit and Marc Stappers

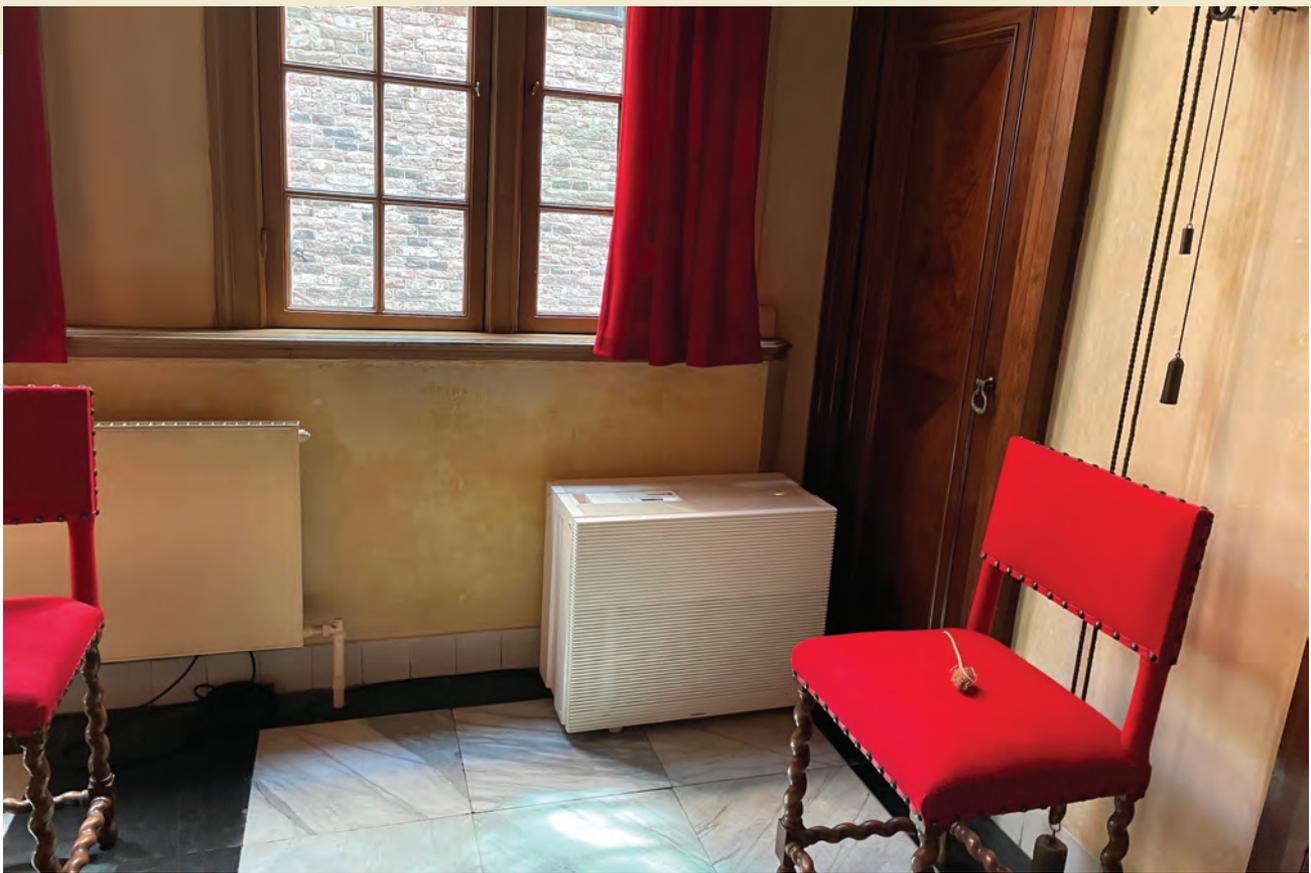
IMAGE 9 (top). Climate control in the historic building is by a small number of radiators and an occasional humidifier in some of the rooms, while the entrance building is fully climatized using HVAC systems. MARC STAPPERS **IMAGE 10 (bottom).** Climate control in the historic building is by a small number of radiators in only a few rooms, while the entrance building is fully climatized using HVAC systems. BART ANKERSMIT

winter temperature of 17–18°C (62.6–64.4 °F) and expand the museum volume with an extra adjacent building (Images 9 and 10).

The two buildings, separated by a small alley, are connected by an underground passage. The renovated building became the new entrance and presented the valuable and susceptible objects in display cases.

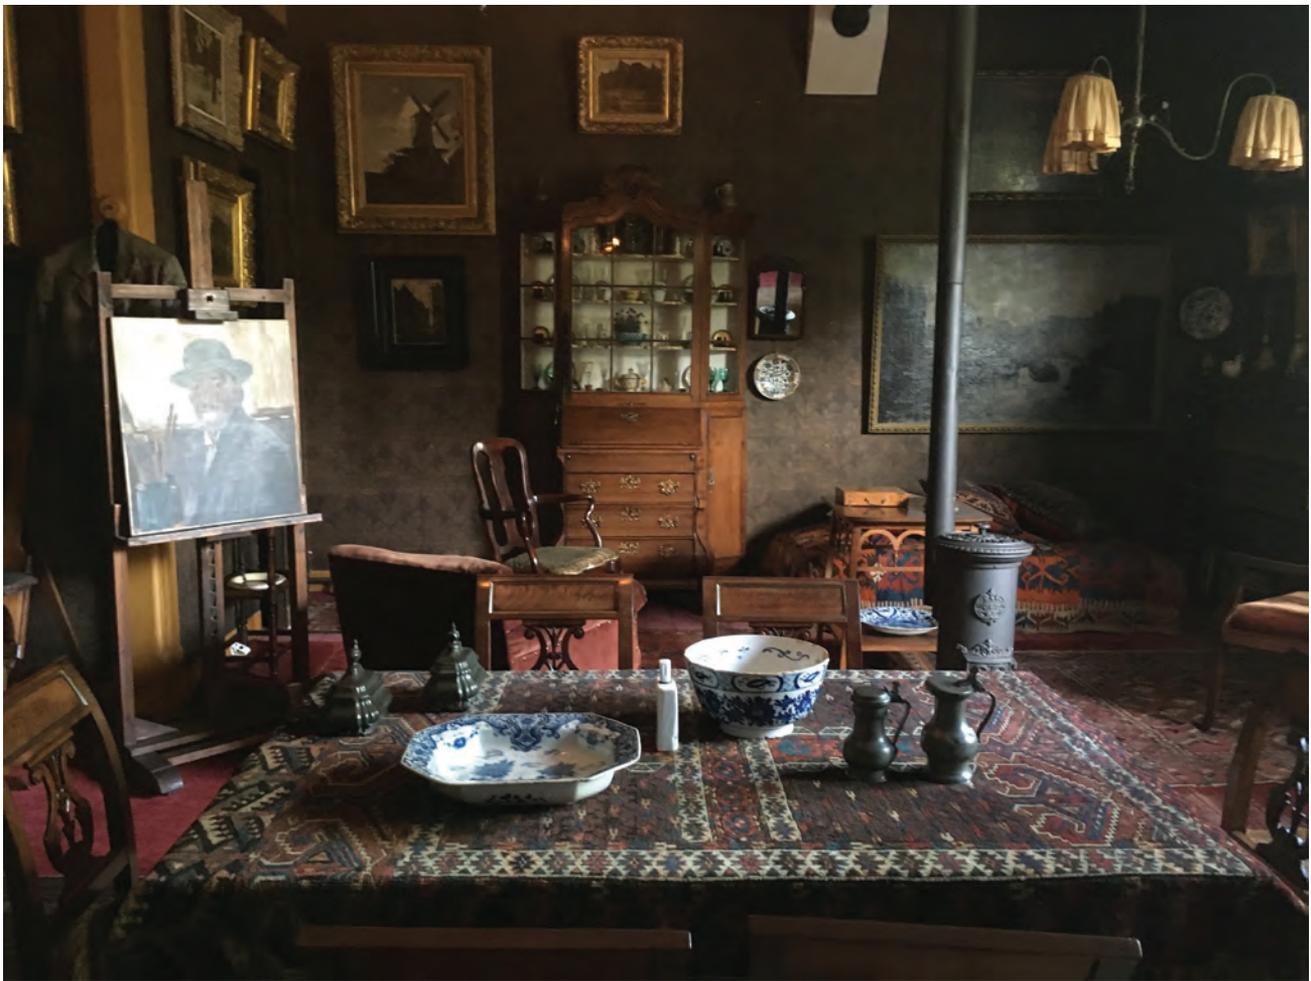
IMAGE 20. The interior of the Witsenchamber with a datalogger on the table and the furnace for a small amount of heat on the right. BART ANKERSMIT

The apartment can be visited by appointment (Image 20). The apartment has very limited climate control: a little heating but no moisture control. In 2020, the small organization of volunteers who check the condition of the collection regularly and give tours to visitors noticed signs of mold on the book collection. It was decided not to
