## Why do we keep doing this?

### An argument for informed environmental assessments

*David Bittermann, AIA*

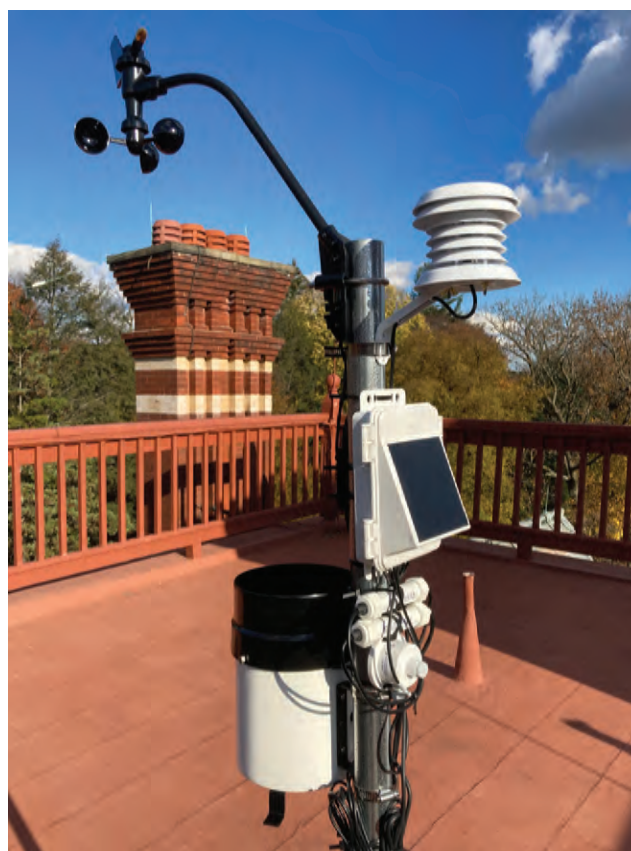
**FIGURE 2.** Weather station at Edison’s Glenmont. DAVID BITTERMANN

Data should include, at a minimum; indoor temperature and relative humidity (with calculated dew points) in representative locations throughout the structure, and especially in rooms containing the respective “canaries.” Data should also include exterior temperature, relative humidity (with calculated dew points), wind speed and direction, barometric pressure, and rainfall (Figure 2). Data should include differential pressures (in inches water column) between mechanical spaces and other spaces, and between indoors and outdoors (Figure 3). If the mechanical system includes cooling, humidification, and/or dehumidification via a ducted system, then data would need to include temperature and relative humidity (with calculated dew points) at supply air registers in critical spaces (Figure 4) and at each air handler discharge (Figure 5). Finally, various air quality monitoring may be indicated, including indoor CO<sub>2</sub> levels in ppm (Figure 6) as well as indoor and outdoor particulate levels (PM<sub>2.5</sub> AQI) (Figures 7 and 8).

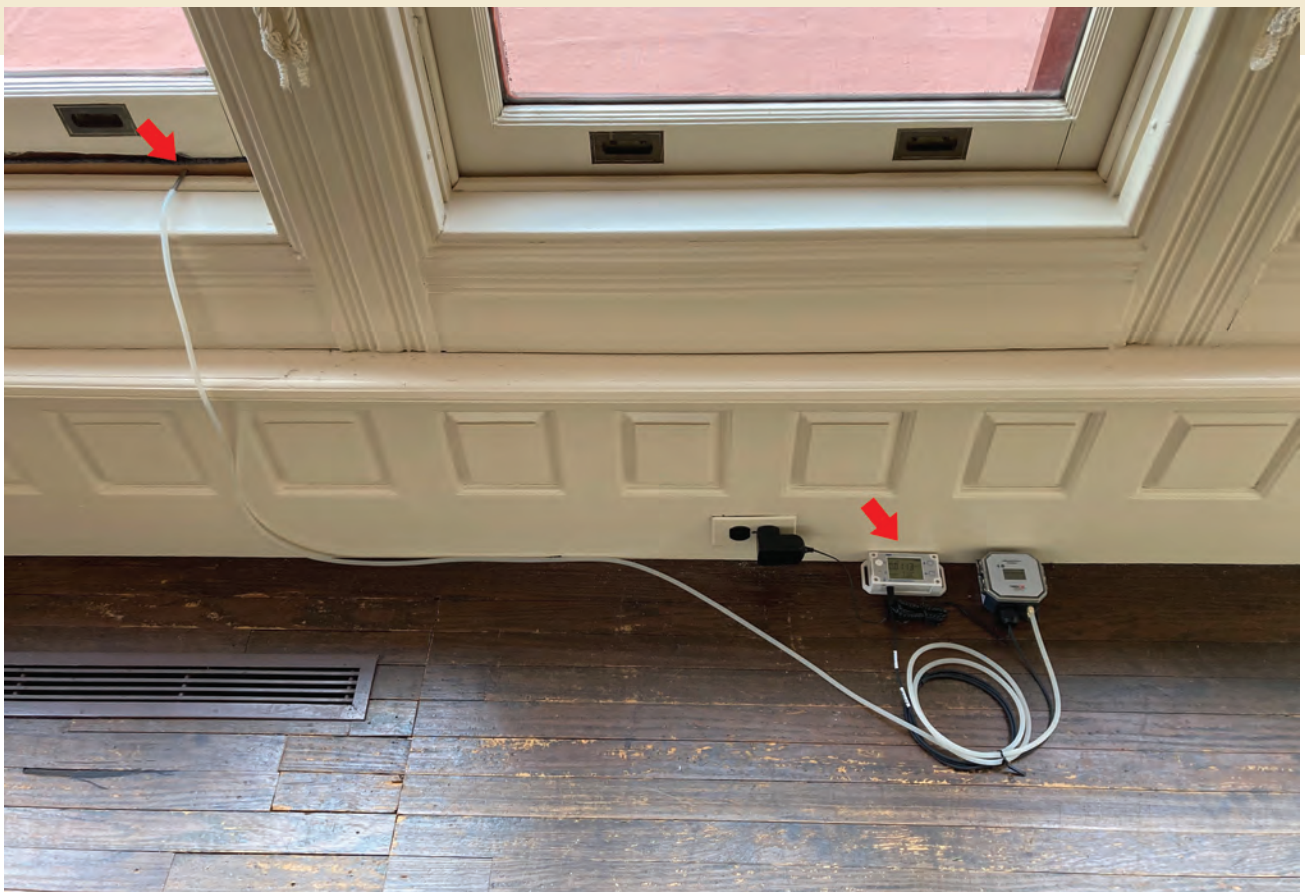
**FIGURE 3** (above). Monitoring differential pressure between interior and exterior. **FIGURE 4** (below). Monitoring temperature and relative humidity at supply register. DAVID BITTERMANN

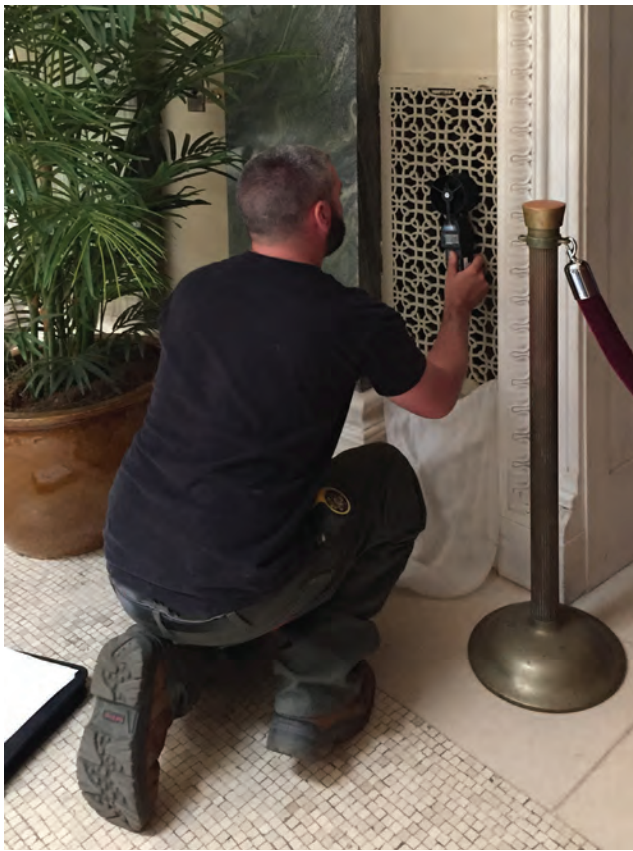
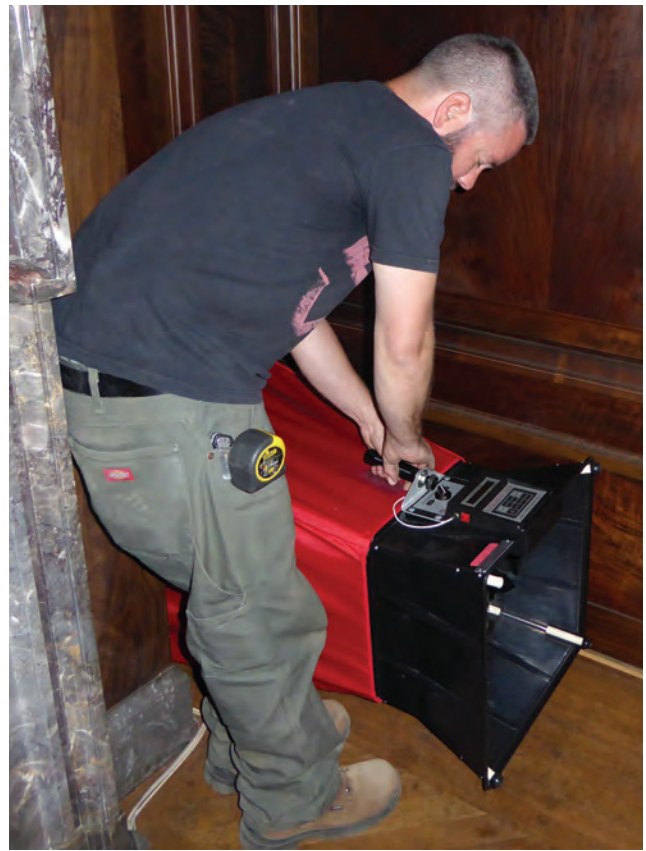
**FIGURE 12 (left).** Measuring discharge rates with anemometer and flow hood (right). LEFT: DAVID BITTERMANN RIGHT: MARGARET BREUKER, HACE

static pressures at the air handlers (Figure 11) and discharge rates at each supply register (Figure 12), along with associated sound levels. These testing results in particular provide important baseline information against which to compare future results after any system modifications.

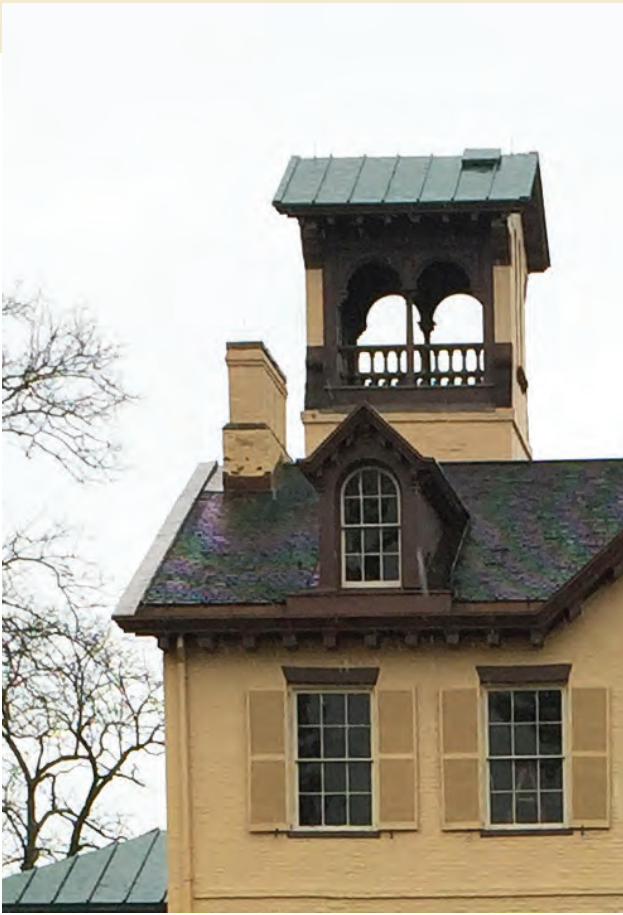
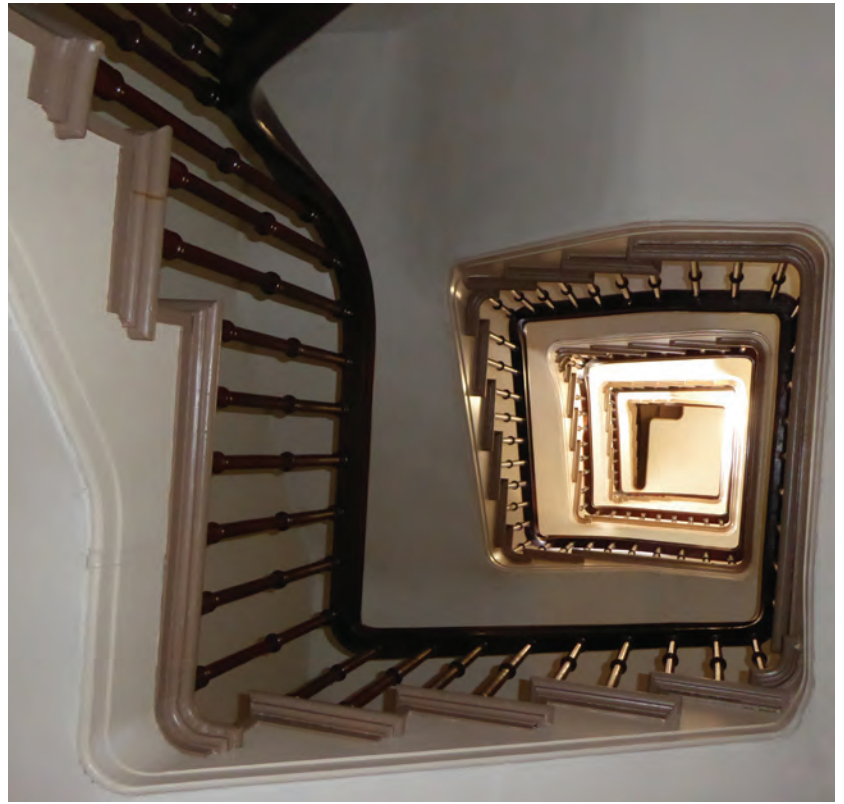
**FIGURE 17 (left).** Lindenwald—ventilating tower. DAVID BITTERMANN **FIGURE 18 (right).** Lindenwald—tower stair. MARGARET BREUKER, HACE

Use the original design features of the historic structure to best advantage, where possible.<sup>11</sup> Open and close windows at appropriate times. Maximize informed use of historic ventilating features (towers, light and air shafts, central hallways, roof hatches, skylights, etc.) (Figures 17, 18).
